Arch Chemicals, Inc.

Tank Car's  
17054, 17056, 17072,  
17073, 17074, 17075, 17077,  
17081 and 17091

External Visual  
and  
Nondestructive Examination Report  
of  
Pressure Containing Vessel

METco - Sulphur

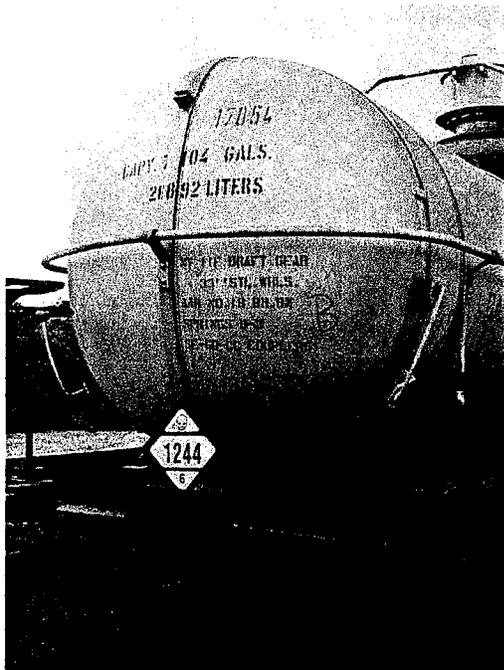
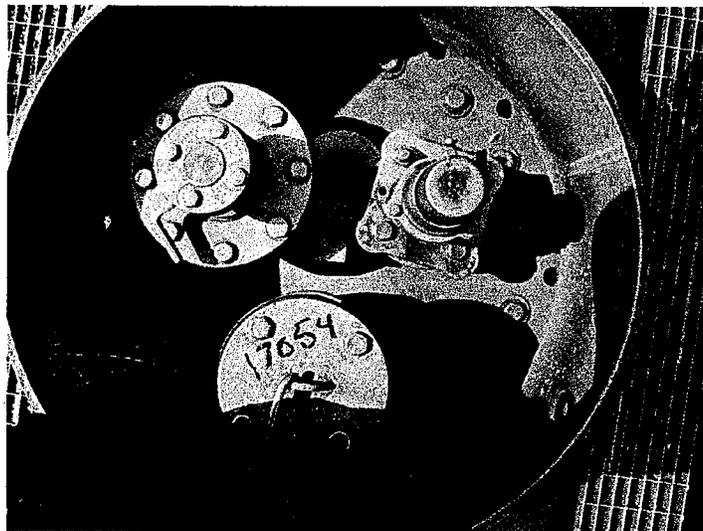
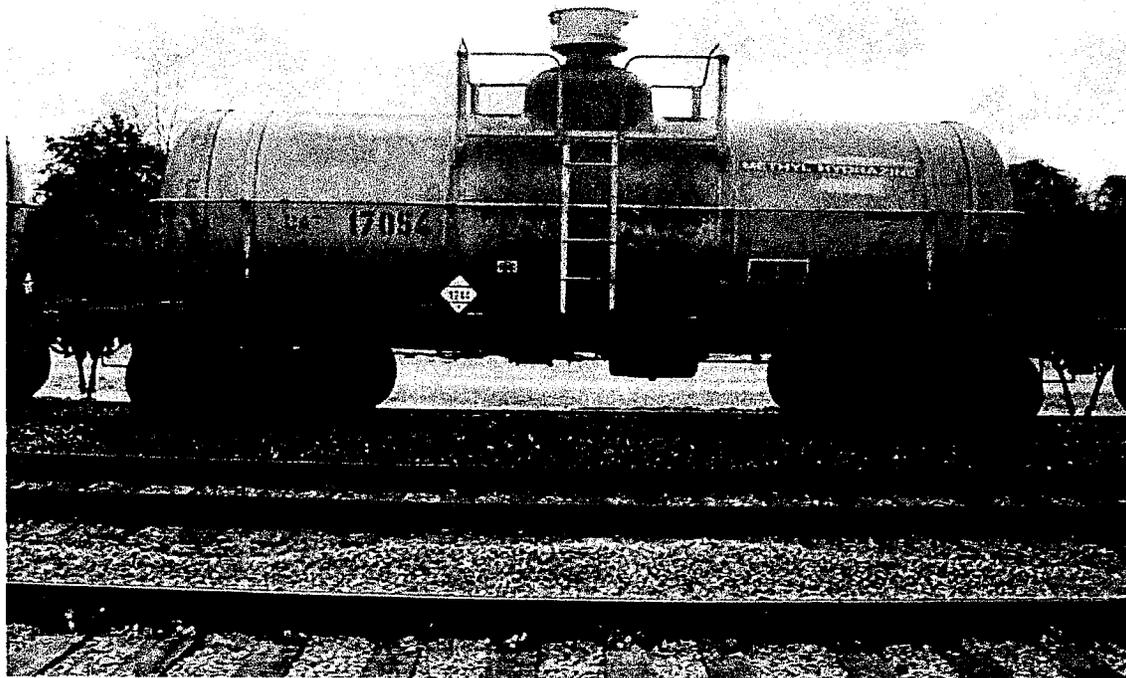
# Tank Car 17054

The tank car appears to be good working condition. No external plate buckles or deformities were noted.

Tank car external coating is faded. Paint has chalky residue, top portion of vessel has red paint which appears to be primer.

All External attachments for handrails and walkways are in usable condition.

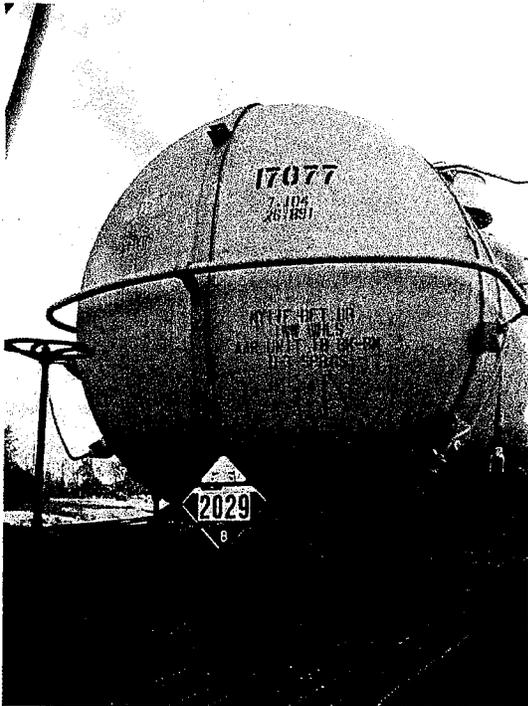
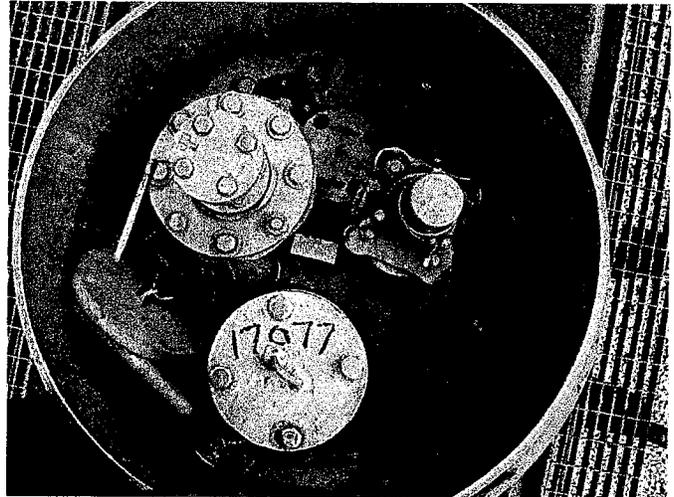
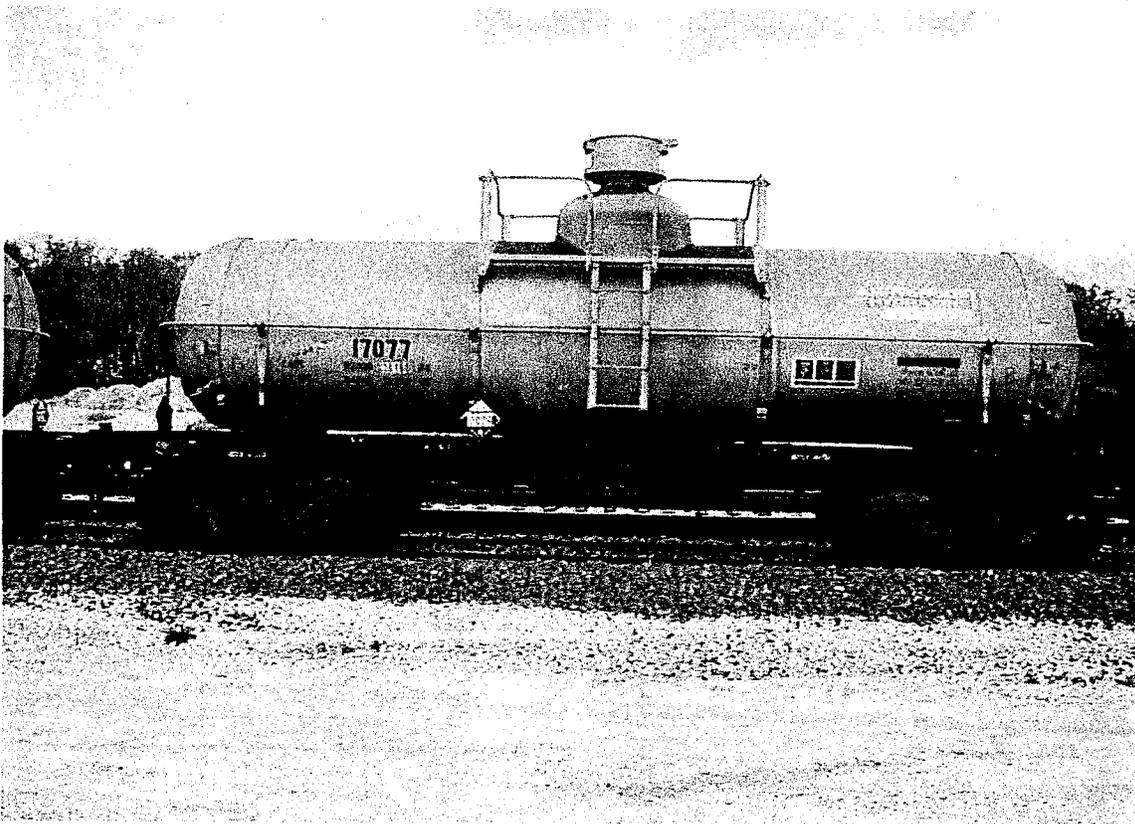
# Tank Car 17077

The tank car appears to be good working condition. No external plate buckles or deformities were noted.

Tank car external coating is in good condition. Paint has chalky residue but appears to be adhered well.

External attachments for handrails and walkways are in usable condition. Top handrail on the A-B side toward Head A is broken and in need of repair

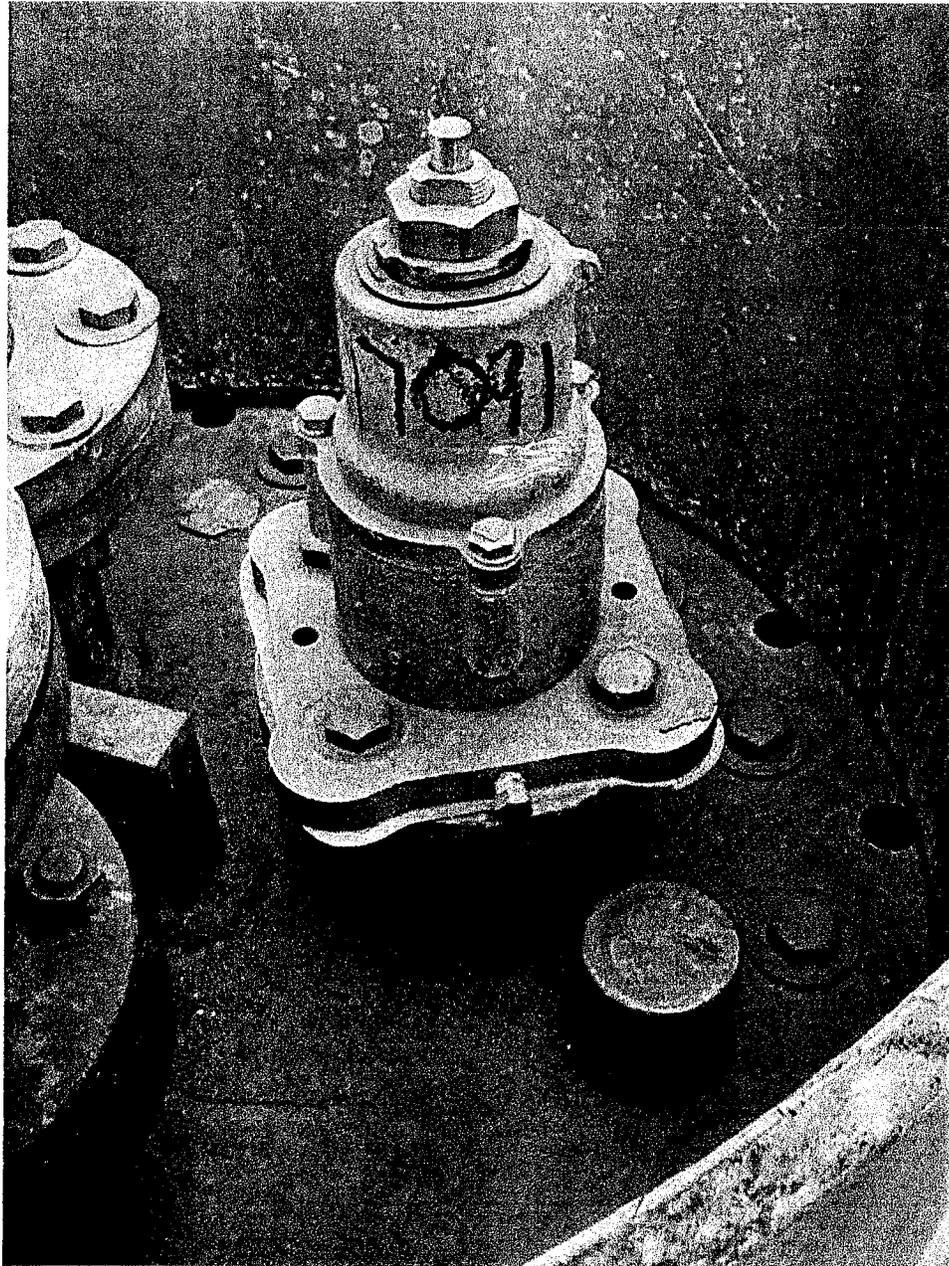
Broken Safety Relief Valve

All External attachments for handrails and walkways are in usable condition. PSV has no tag or information attached, the cap is broken off the PSV. See attached picture of PSV.
