DESC Contract No. SP060099D5944

Report of Site Visits in Support of an Investigation of “Apple Jelly” Contaminant in Military Jet Fuel

March 2002

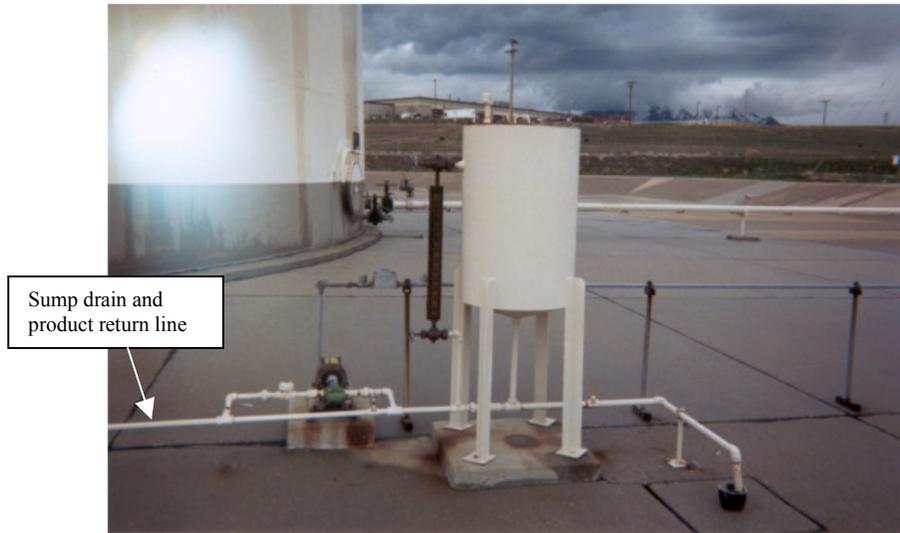
The product recovery system pictured above has been abandoned because of lack of utility and this same tank is currently drained by running a 1 ½” rubber hose across the diked area and into the bowser shown below.

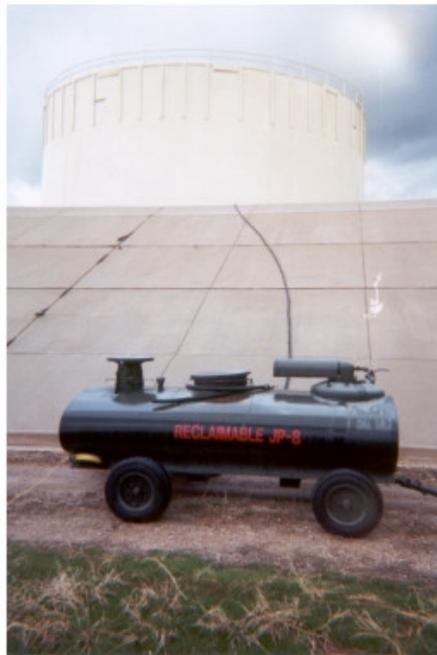
Product recovery systems at Fairchild have also been abandoned in favor of using a bowser, like the one above, to draining tank bottoms. Likewise, the product recovery

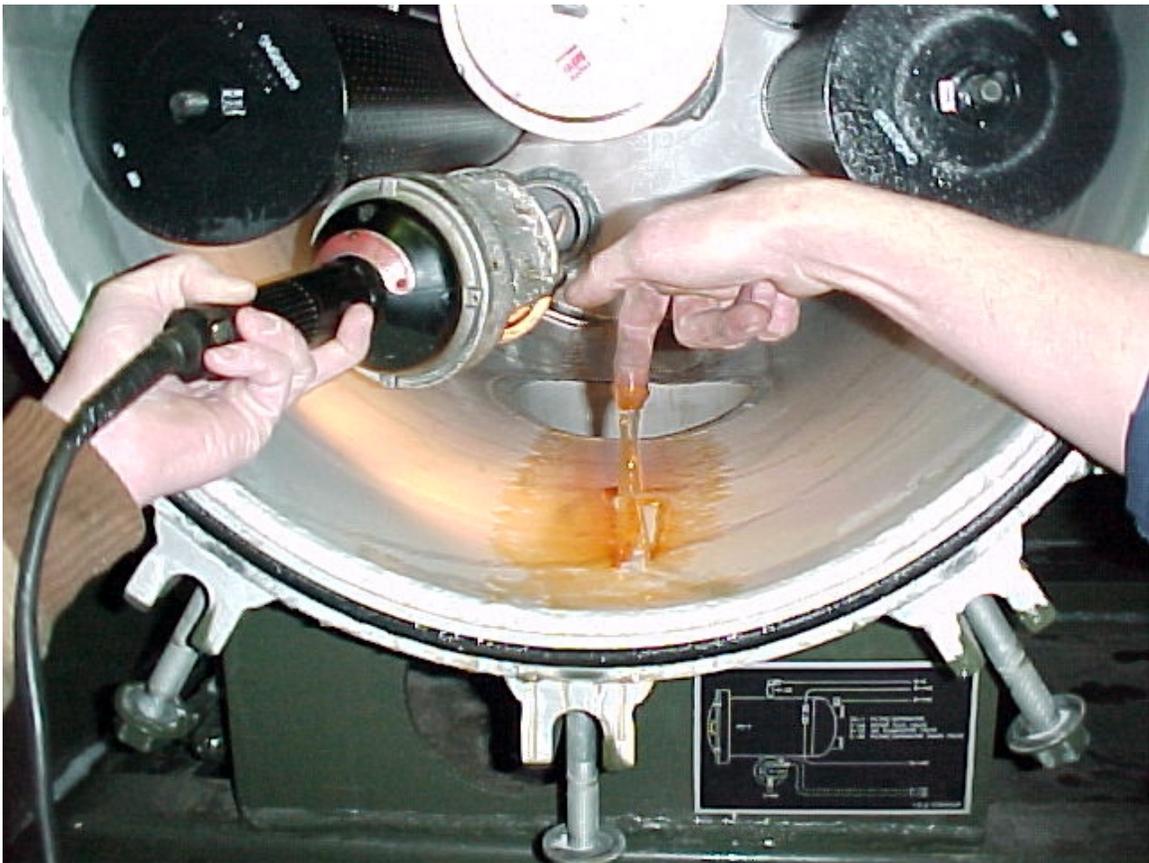
(Photo provided by Youngstown ANG)

During the onsite investigations, it became apparent that some general characteristics of AJ differ depending upon the location in the fuels logistics systems where the AJ materials were found. Materials drained from the sumps of receipt and issue F/S vessels were generally similar in viscosity to a free-water/FSII mixture. The same was true of most materials drained from bulk storage tank sumps and found in the bottom of product recovery tanks. However, the thickest, most viscous forms of apple jelly were found to be associated with the R-11 refueler equipped with water absorption media filters. This type of AJ material is occasionally drained in small amounts from the filter vessel sumps, but is more frequently found in the bottom of the filter vessel, as shown in the photograph below.

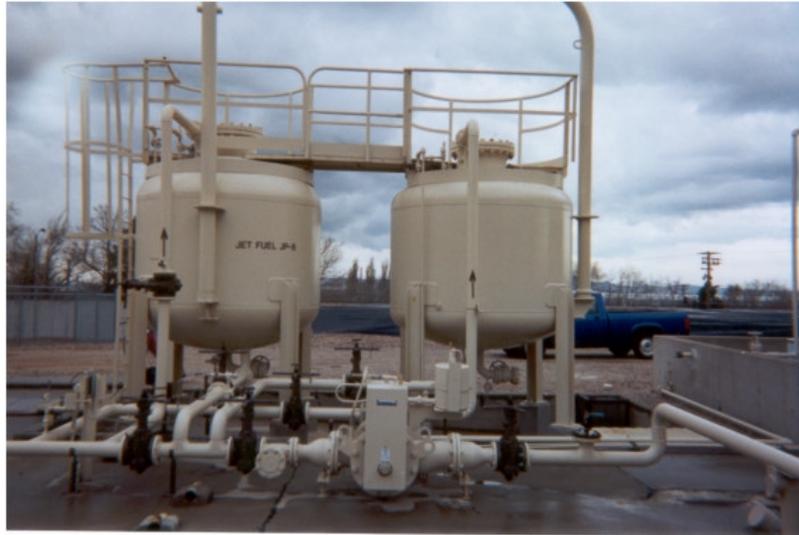
Once each six months, Hill AFB receives JP-8 by pipeline to exercise that receipt mode. The pipeline is a 6-inch diameter line that comes from the Chevron Refinery near Salt Lake City. While no pipeline drag reducer (PDR) is used in this line, it was reported that the Pioneer Pipeline from Sinclair's Rawlins Refinery, which does use PDR in diesel movements, connects to the Chevron line and provides approximately 100,000 bbls of Jet A to Delta Airlines at the SLC Airport each month. Additionally, fuel is occasionally pumped from SLC Refineries through the Chevron Pipeline to Pasco, Washington. Hill AFB is unique in that three additives are injected on base as the fuel is received: Corrosion Inhibitor, SDA, and FSII. Prior to injection, the fuel is filtered through one of two clay filters (manufactured by Eaton Metal Products). These on-base clay filters are set in parallel and only one of the two filters is equipped with a pressure differential gauge.

The three additives are injected using a Hammonds injector (model # D25XFCPHHHC / 1400-D25-1S-1S). The three additive streams are manifolded into a common nipple prior to injection, in effect mixing the additives prior to injection. The three additives enter the pipeline upstream of the paddle wheel that powers the injector pistons. While there are no specific indications of problems at Hill AFB resulting from the use of a single injection point for the three additives, the more common and recommended procedure is to inject the additives at three separate points.

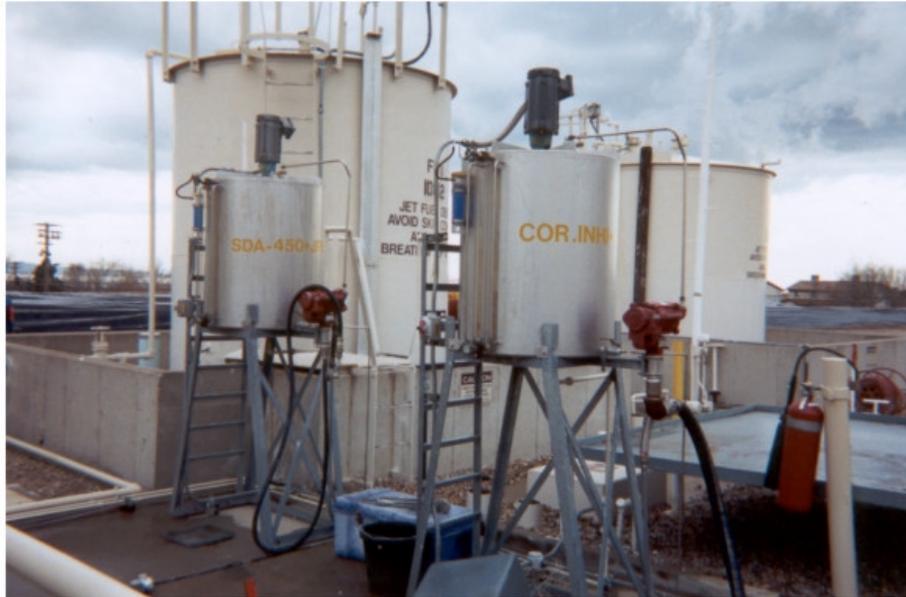
Neither of the two FSII storage tanks is equipped with moisture control, such as a desiccant or nitrogen blanket. Fuels personnel did not know the pumping rate nor the

inside diameter of the pipeline information needed to compute a Reynolds Number or flow rate at the point of injection.

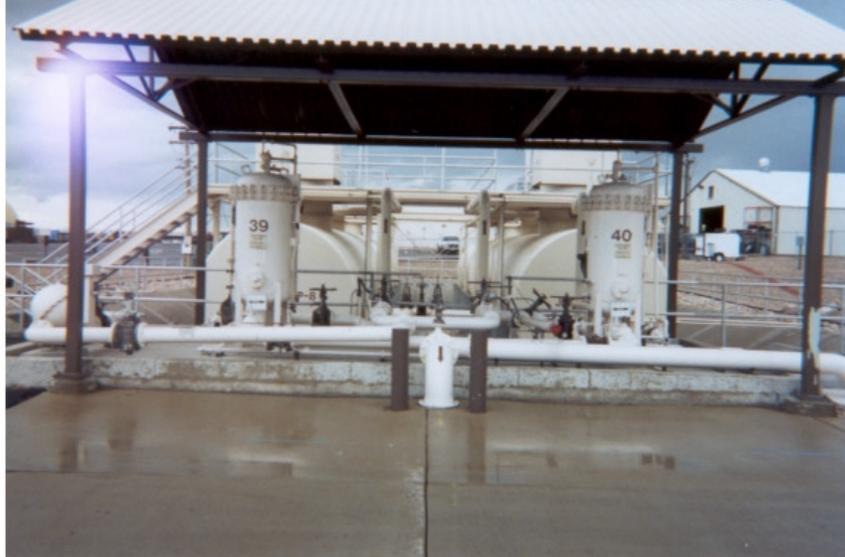
Two 40,000-gallon, horizontal tanks (Tanks # 39 and #40), which receive from bulk storage without filtration, supply the truck fillstands. Storage operators usually drain from one pint to one quart of “orange colored water” from the tanks each morning. A sample was taken from the low point drain during our afternoon visit was found to be clear and bright. The fill stands are equipped with two vertical F/Ss (manufactured by Keene Corporation, model #330 V600 manufactured in 1974). These F/S vessels use the old DoD elements, FSN 4330-00-983-0998. This old style element was marginally

effective for use with JP-4 and is ineffective for use with JP-8. The filter vessels should be replaced with API qualified vessels.

Currently, this is the first filtration that JP-8 delivered by tank truck is subjected to before it enters the flight line refuelers. Most of the jet fuel issued by Hill AFB is JP-8+100. The +100 additive is injected downstream of the fillstand F/S vessels.
