Arch Chemicals, Inc.

Tank Car's  
17054, 17056, 17072,  
17073, 17074, 17075, 17077,  
17081 and 17091

External Visual  
and  
Nondestructive Examination Report  
of  
Pressure Containing Vessel

METco - Sulphur

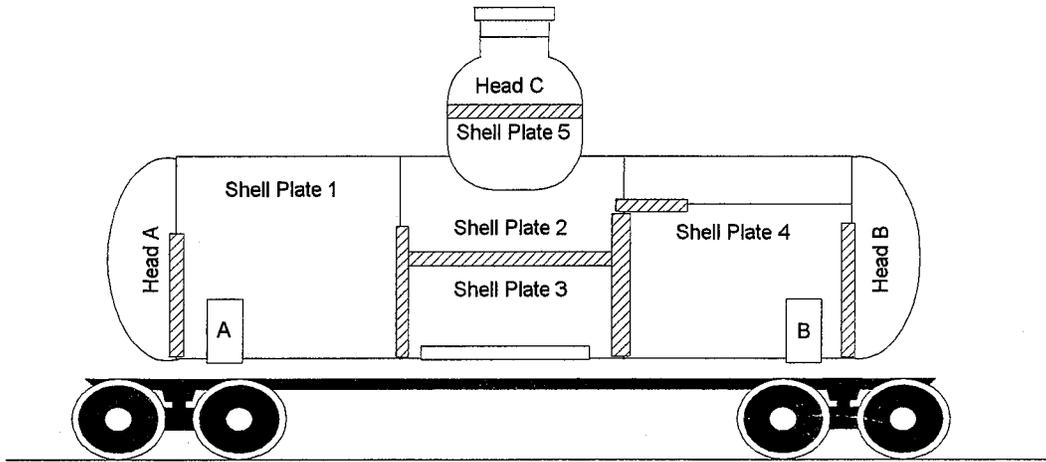
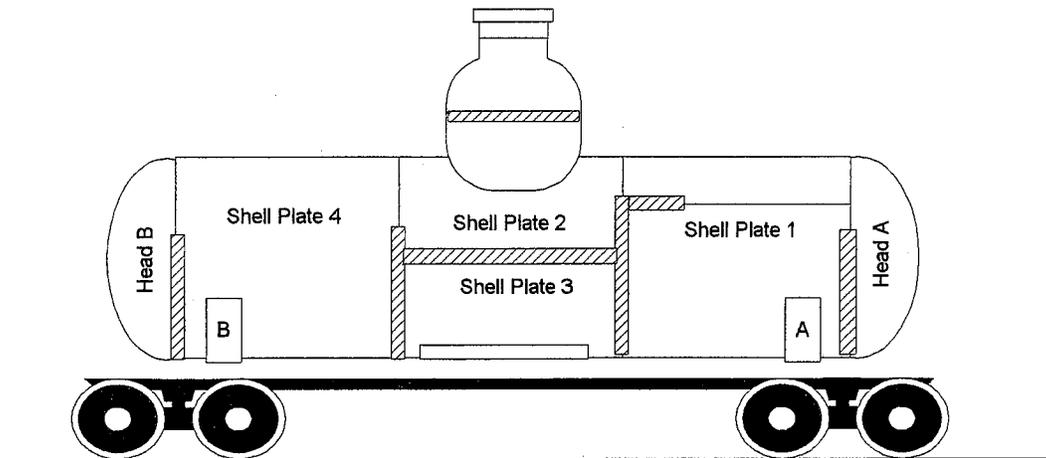
## Location of Ultrasonic Shear Wave Examinations

The results of the examination did not show any evidence of internal cracking or wall loss at the weld seams examined. The vessel had stencil numbers stamped next to the weld seams indicating possible radiographic examination was performed during fabrication. No rejectable indications were noted in any weld seams examined.

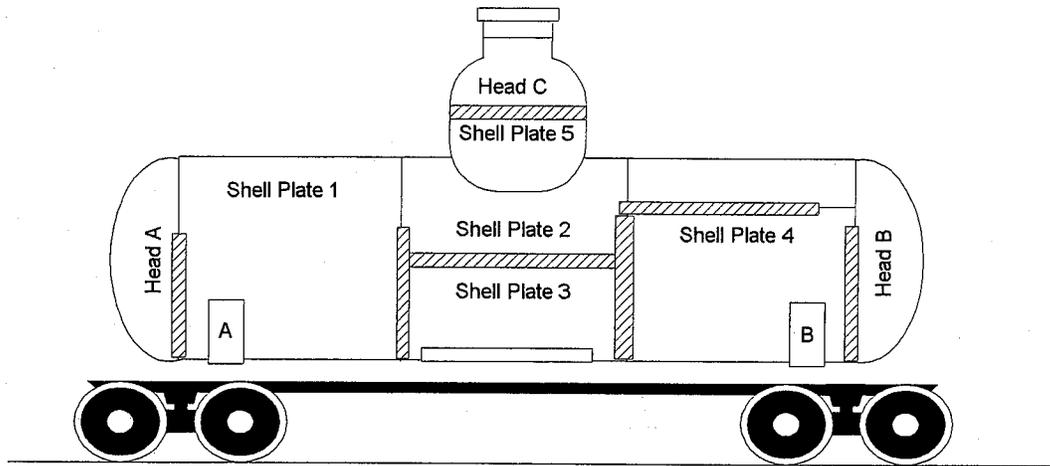
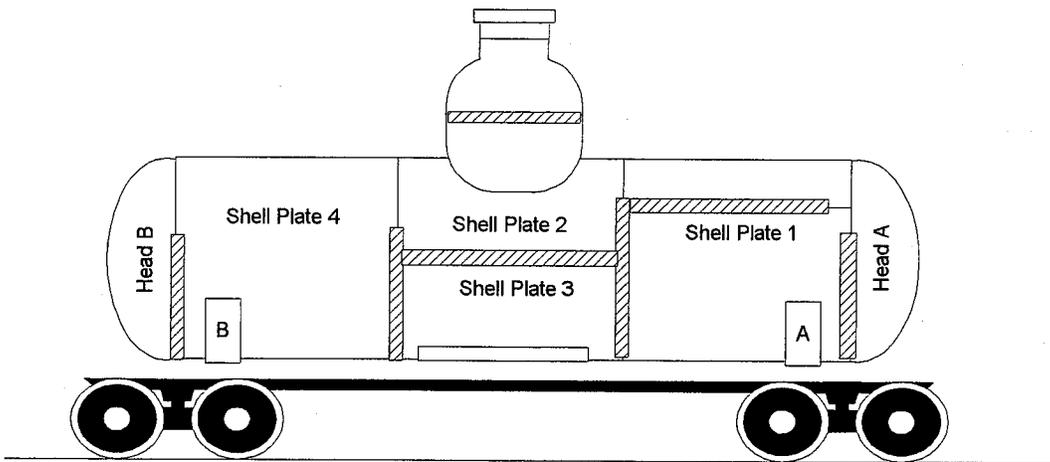
## Location of Ultrasonic Shear Wave Examinations

The results of the examination did not show any evidence of internal cracking or wall loss at the weld seams examined. The vessel had stencil numbers stamped next to the weld seams indicating possible radiographic examination were performed during fabrication. No rejectable indications were noted in any weld seams examined.

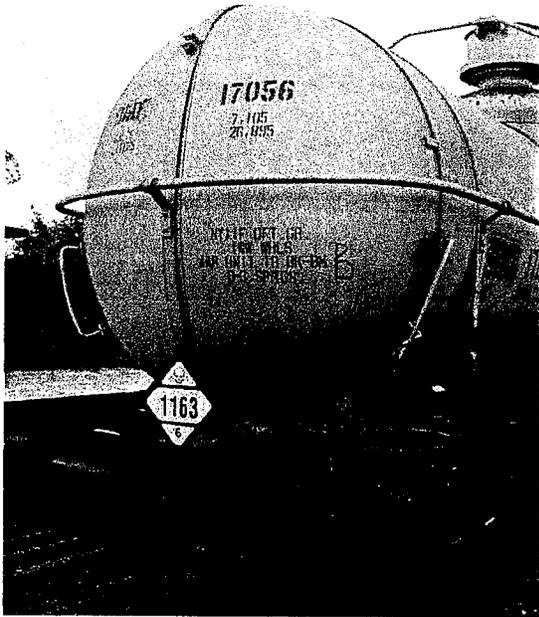
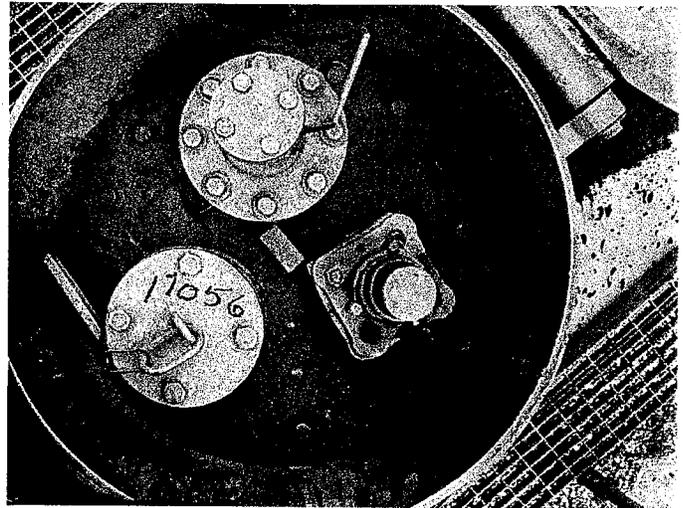
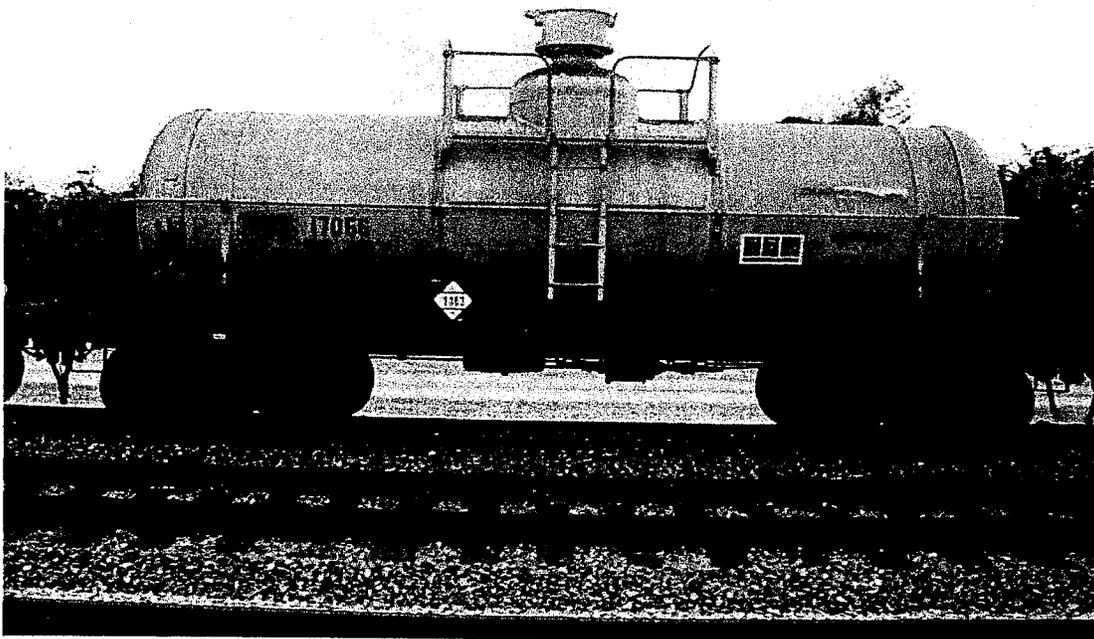
# Tank Car 17056

The tank car appears to be in good working condition. No external plate buckles or deformities were noted.

Tank car external coating is in good condition. Paint has chalky residue but appears to be adhered well.

All external attachments for handrails and walkways are in good condition.

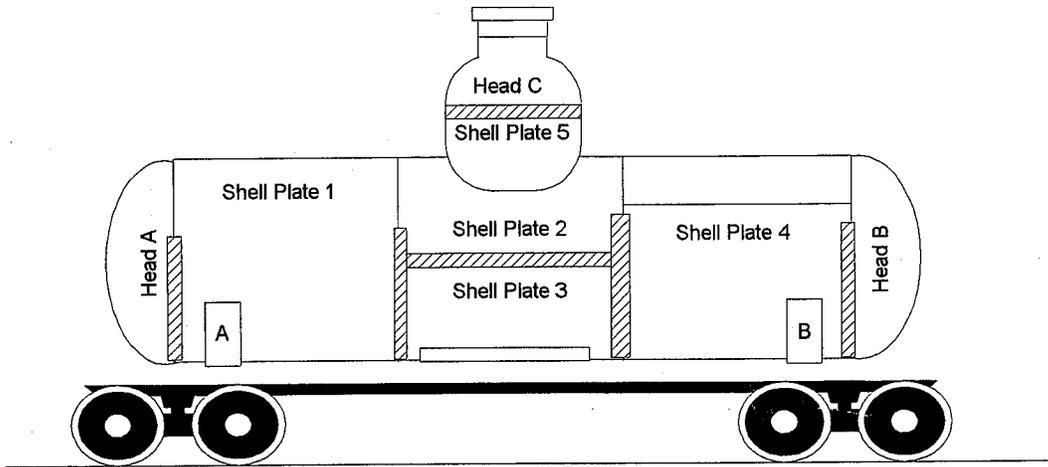
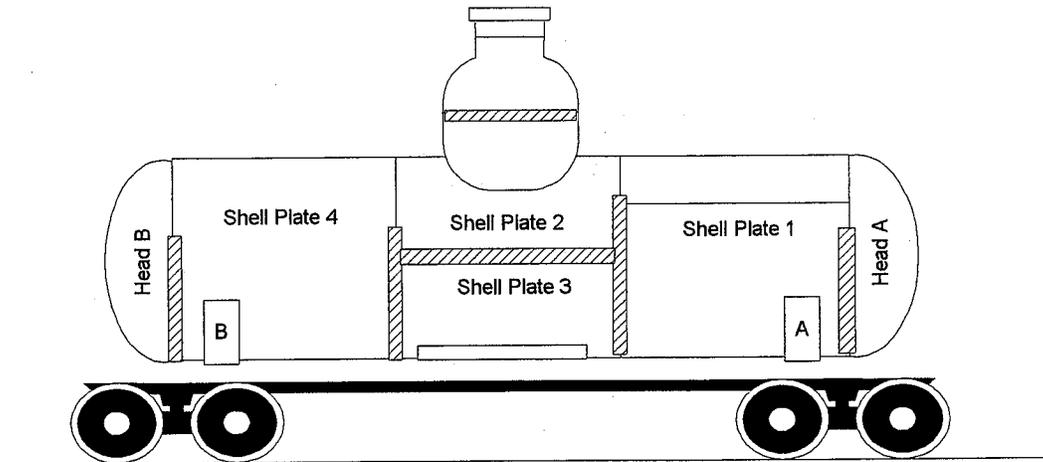
## Location of Ultrasonic Shear Wave Examinations

The results of the examination did not show any evidence of internal cracking or wall loss at the weld seams examined. The vessel had stencil numbers stamped next to the weld seams indicating possible radiographic examination was performed during fabrication. No rejectable indications were noted in any weld seams examined.

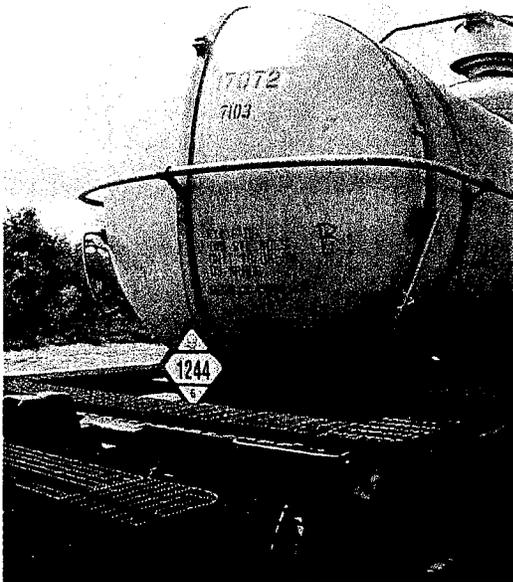
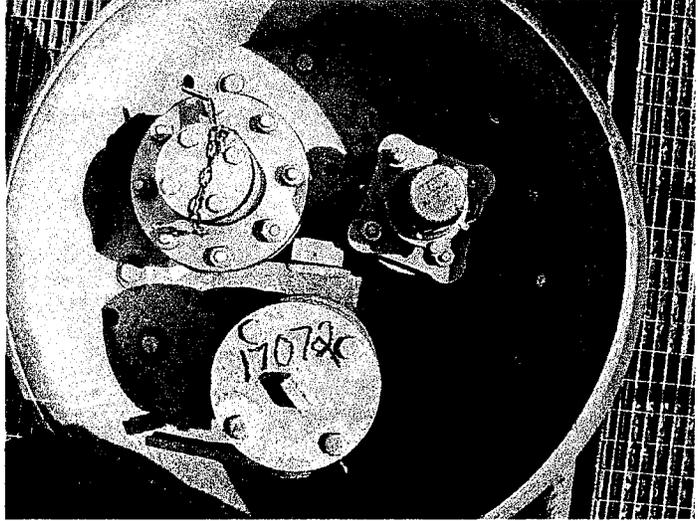
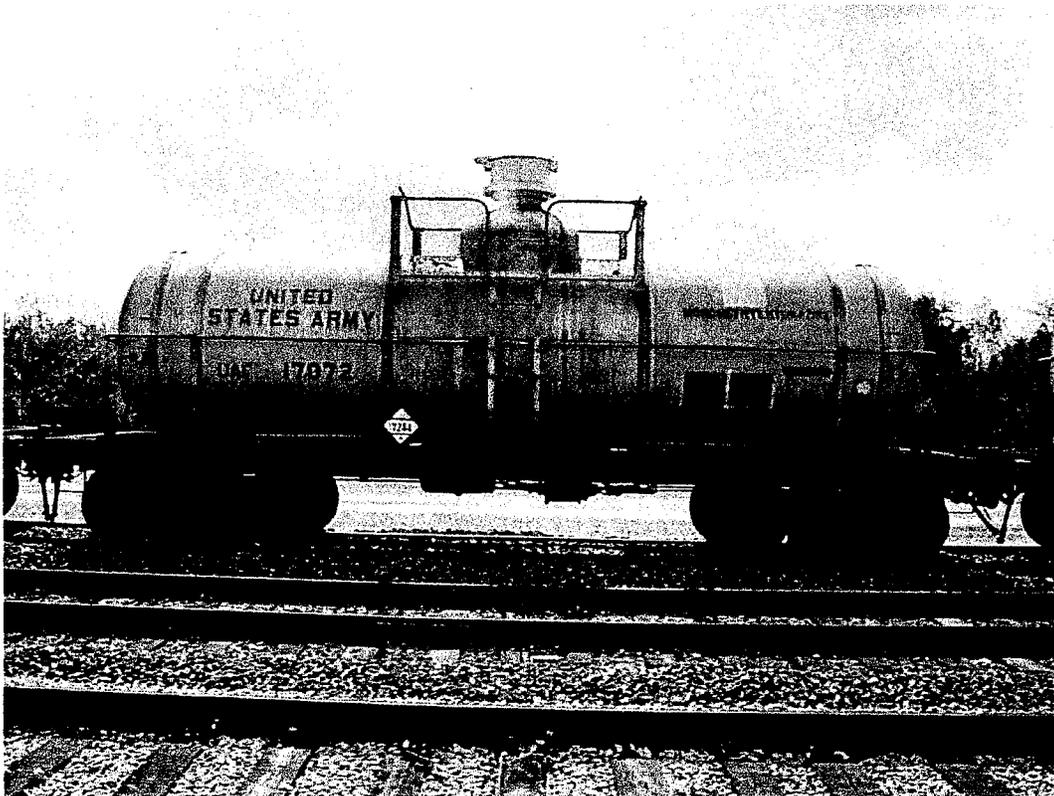
# Tank Car 17072

The tank car appears to be in good working condition. No external plate buckles or deformities were noted.

Tank car external coating is in good condition. Paint has chalky residue but appears to be adhered well.

All external attachments for handrails and walkways are in good condition.

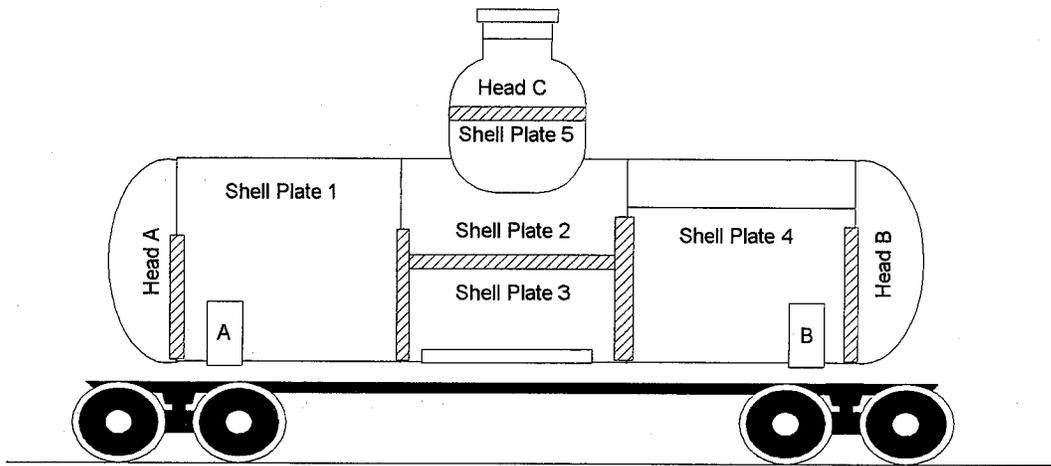
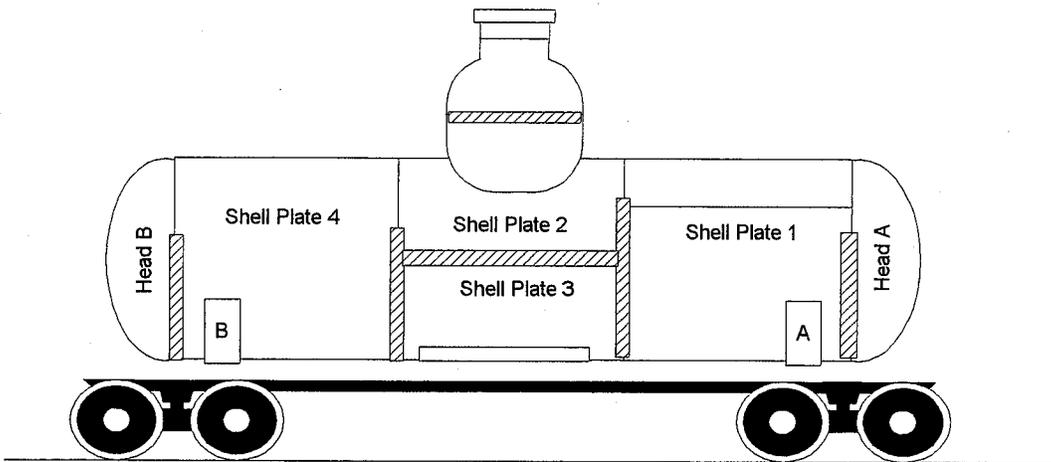
## Location of Ultrasonic Shear Wave Examinations

The results of the examination did not show any evidence of internal cracking or wall loss at the weld seams examined. The vessel had stencil numbers stamped next to the weld seams indicating possible radiographic examination was performed during fabrication. No rejectable indications were noted in any weld seams examined.

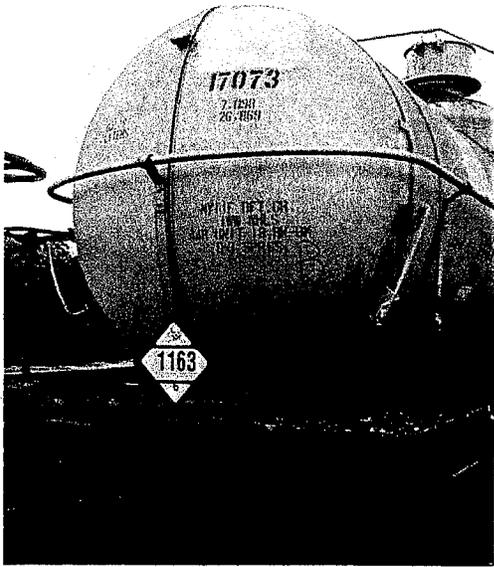
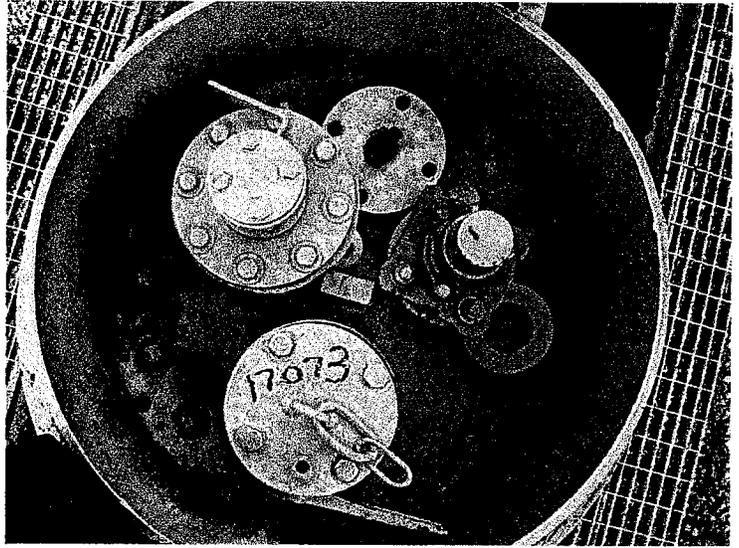
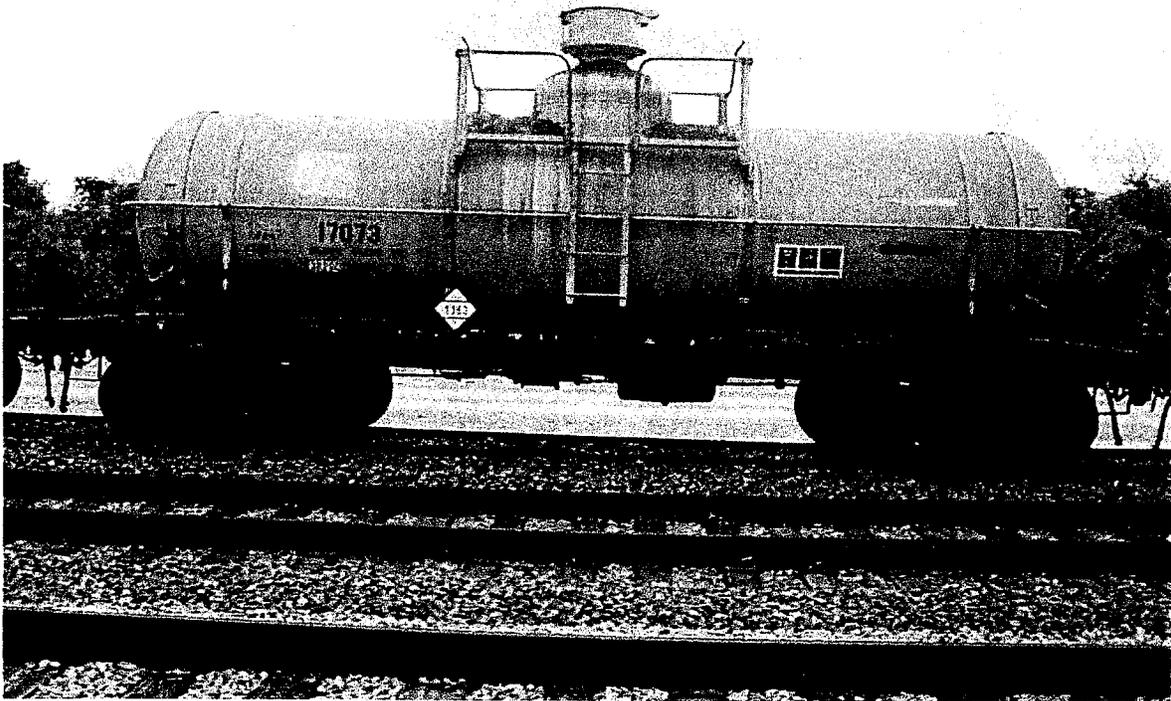
# Tank Car 17073

The tank car appears to be good working condition. No external plate buckles or deformities were noted.

Tank car external coating is in good condition. Paint is faded and has chalky residue but appears to be adhered well.

All external attachments for handrails and walkways are in good condition.

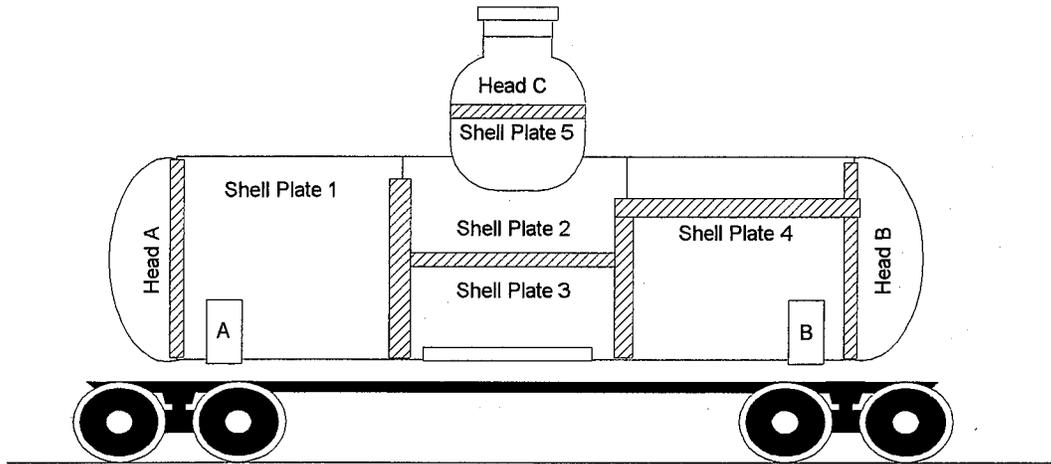
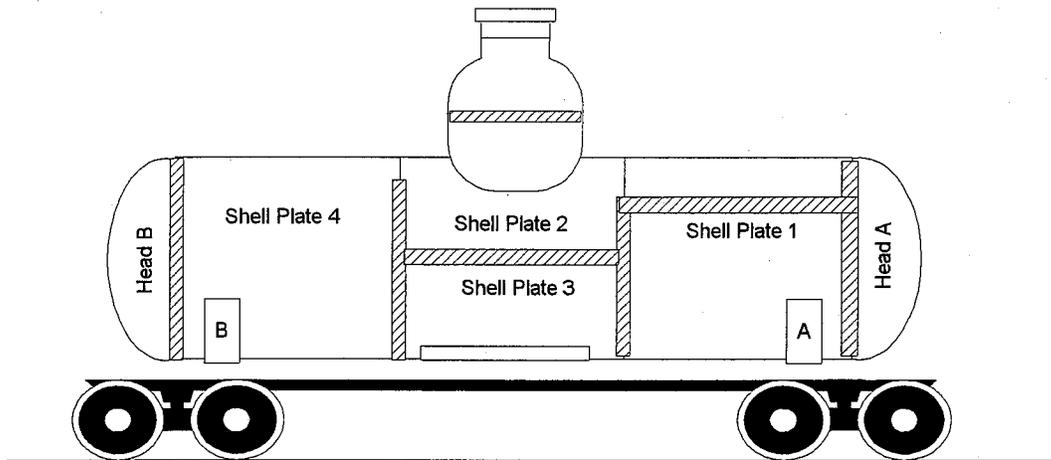
## Location of Ultrasonic Shear Wave Examinations

The results of the examination did not show any evidence of internal cracking or wall loss at the weld seams examined. The vessel had stencil numbers stamped next to the weld seams indicating possible radiographic examination was performed during fabrication. No rejectable indications were noted in any weld seams examined.

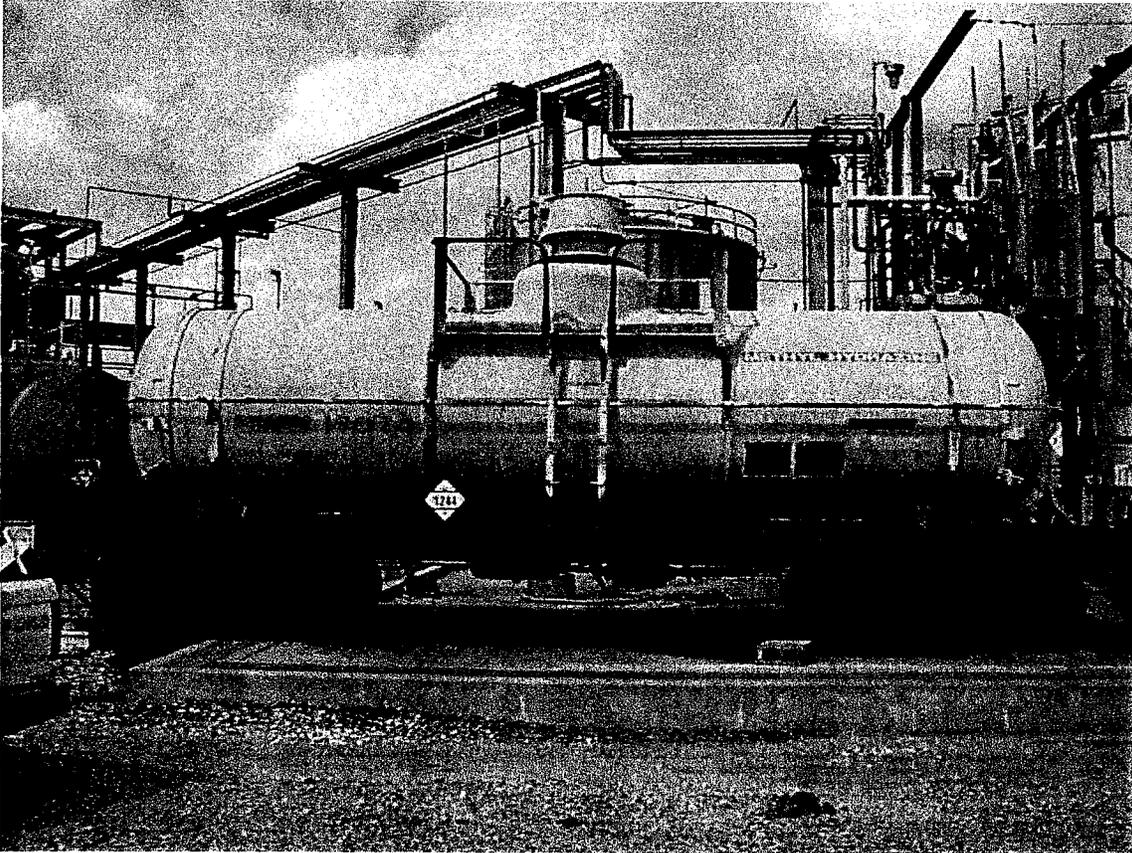
Side View

The tank car appears to be good working condition. No external plate buckles or deformities were noted.

Tank car external coating is in good condition. Paint is faded and has chalky residue but appears to be adhered well.

All external attachments for handrails and walkways are in good condition.

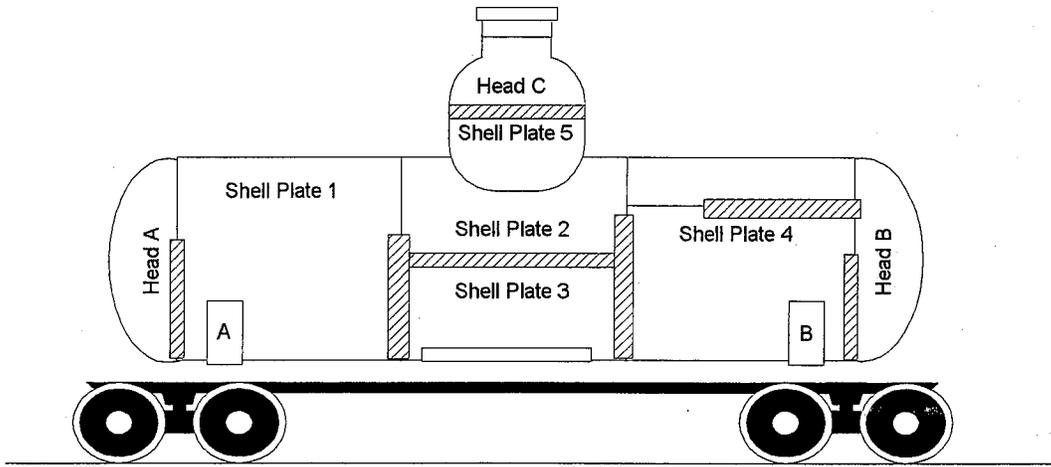
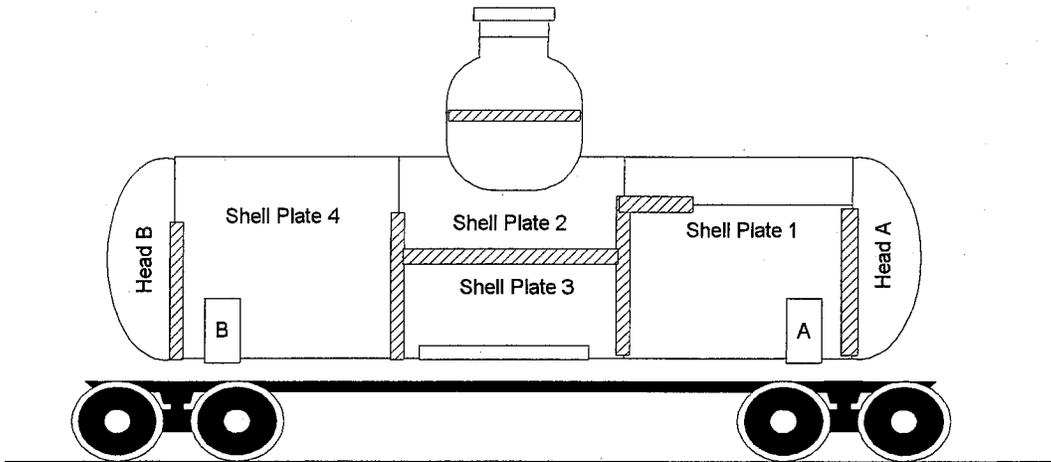
## Location of Ultrasonic Shear Wave Examinations

The results of the examination did not show any evidence of internal cracking or wall loss at the weld seams examined. The vessel had stencil numbers stamped next to the weld seams indicating possible radiographic examination was performed during fabrication. No rejectable indications were noted in any weld seams examined.

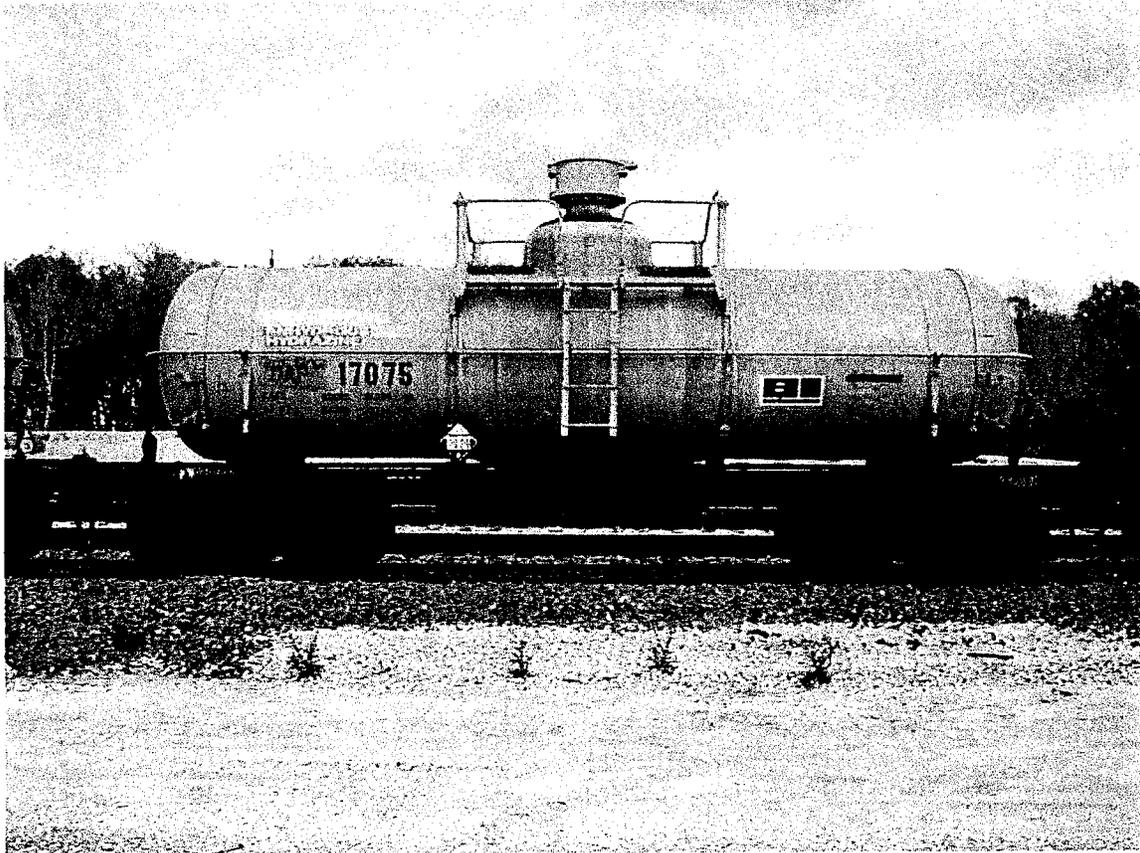
Side View

The tank car appears to be in good working condition. No external plate buckles or deformities were noted.

Tank car external coating is in good condition. Paint has chalky residue but appears to be adhered well.

All external attachments for handrails and walkways are in good condition.

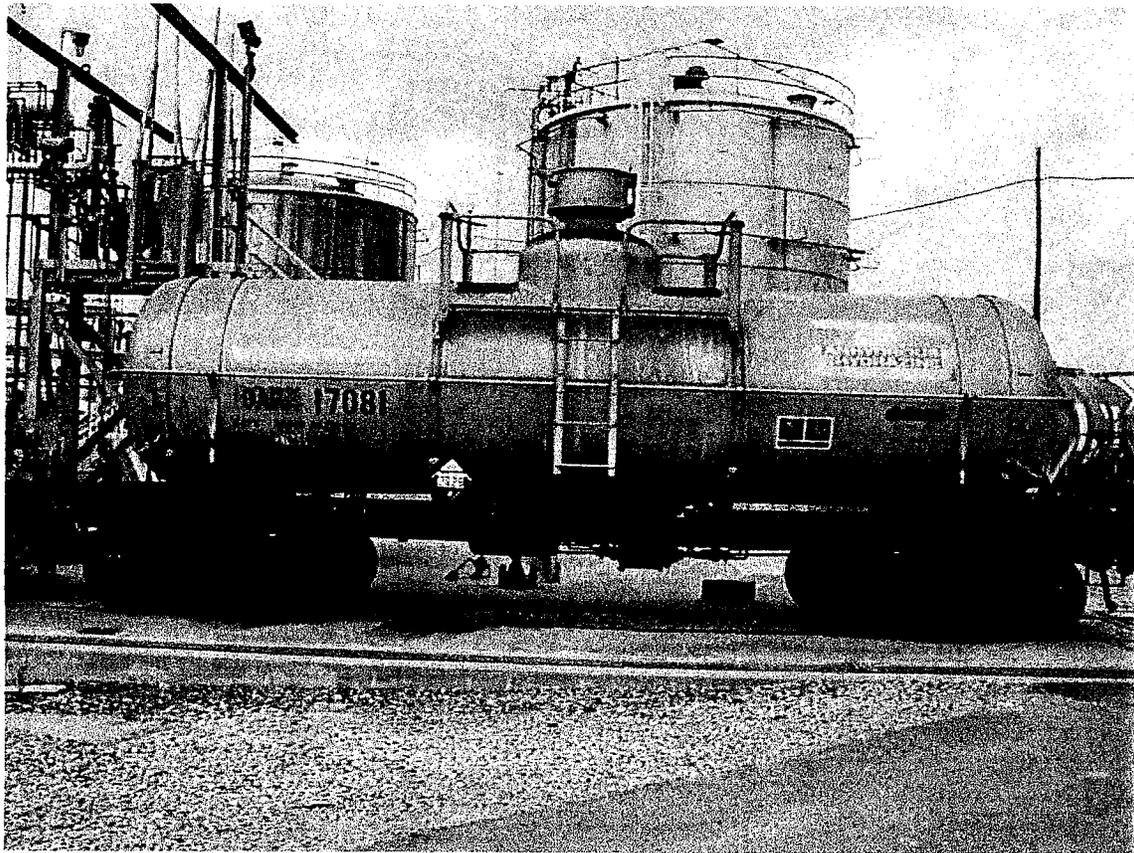
Side View

The tank car appears to be good working condition. No external plate buckles or deformities were noted.

Tank car external coating is in good condition. Paint has chalky residue but appears to be adhered well.

All External attachments for handrails and walkways are in usable condition. PSV has no tag or information attached, the cap is broken off the PSV. See attached picture of PSV.

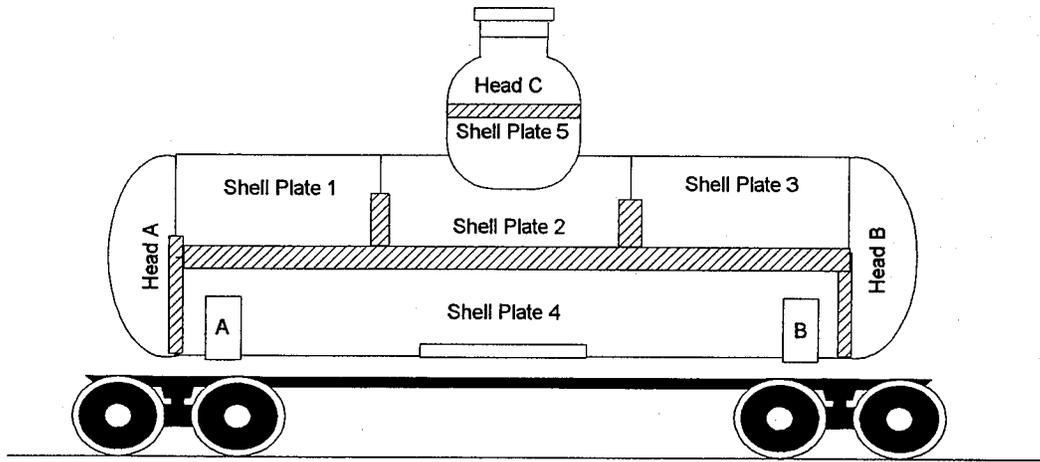
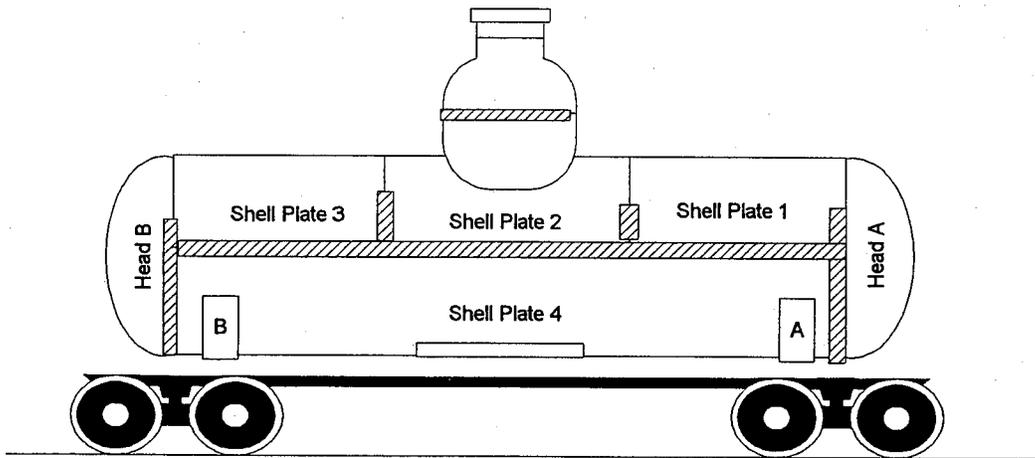
## Location of Ultrasonic Shear Wave Examinations

Indicates Areas Where UT Shear Wave Examination were performed.
